The restoration of the Muhammad Ali Mosque in Cairo, 1931-1938

Mercedes Volait

Mercedes Volait. The restoration of the Muhammad Ali Mosque in Cairo, 1931-1938. Claudine Piaton; Ezio Godoli; David Peyceré. Building beyond the Mediterranean, studying the archives of European businesses (1860-1970) , Honoré Clair, p. 175-183, 2012. halshs-01312322

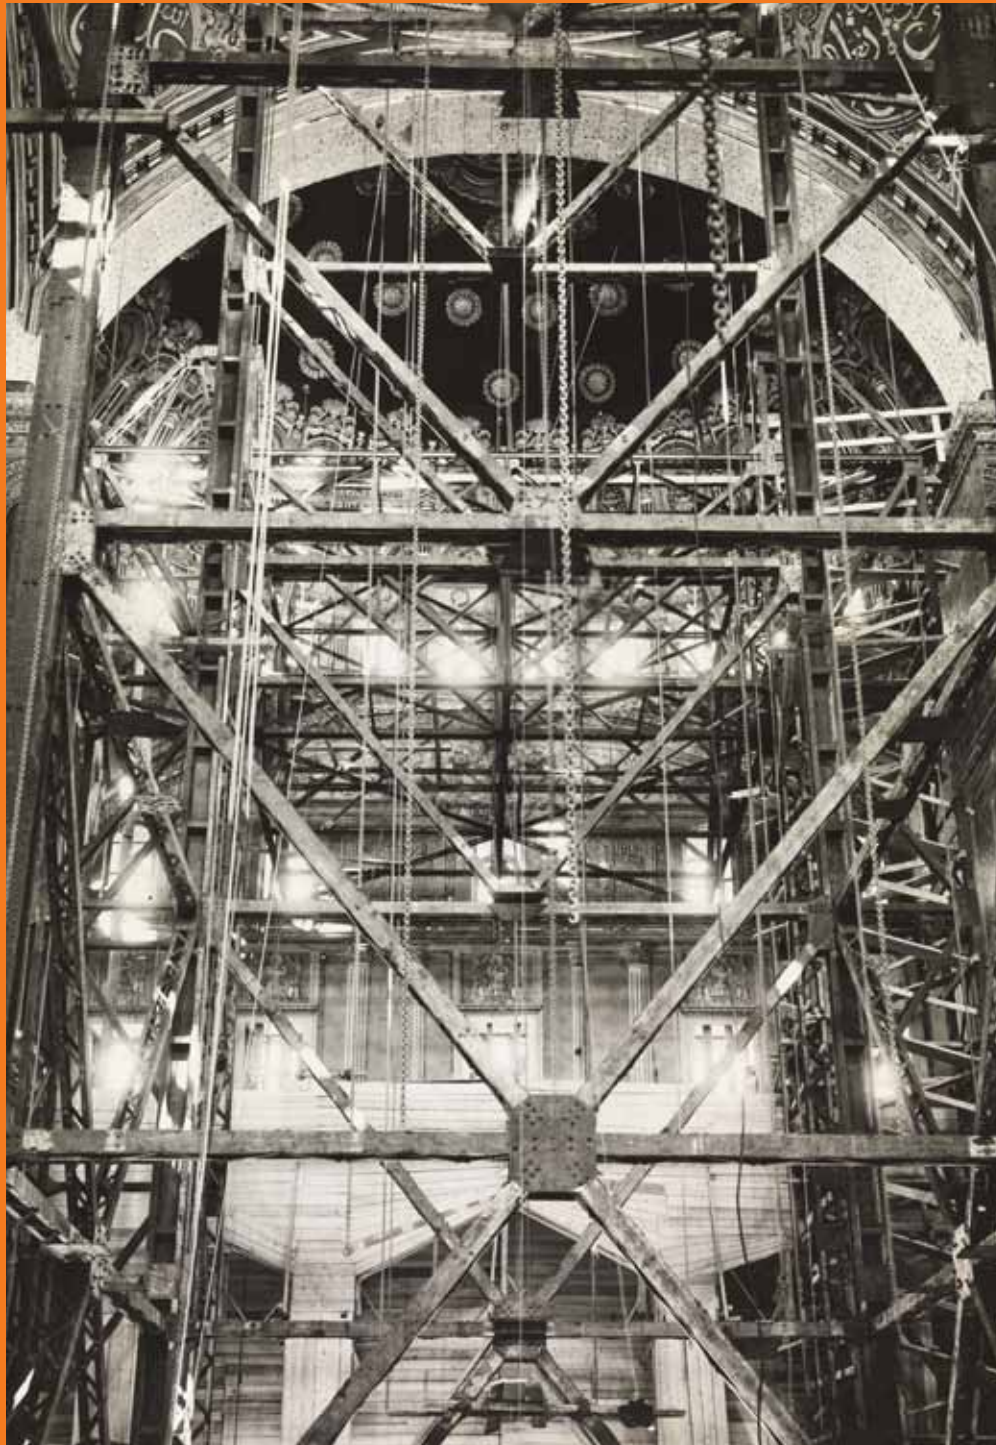
Muhammad Ali Mosque, Cairo: The interior scaffolding for restoration in the 1930s

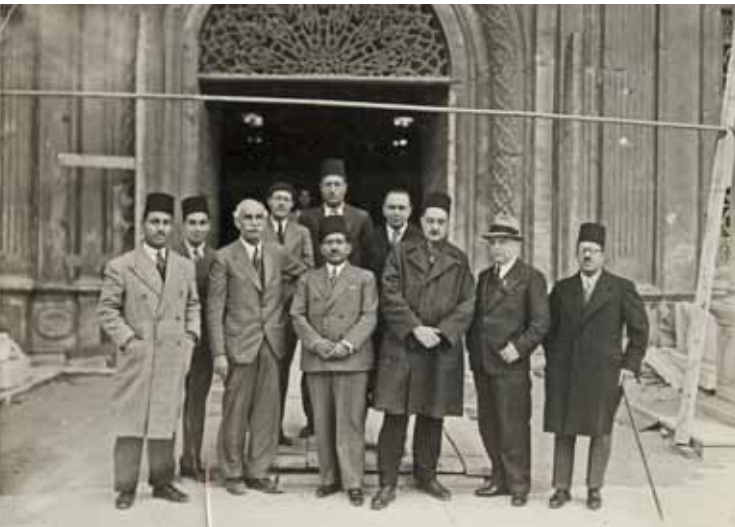
Muhammad Ali Mosque, Cairo: Demolition of the great dome, February 1935

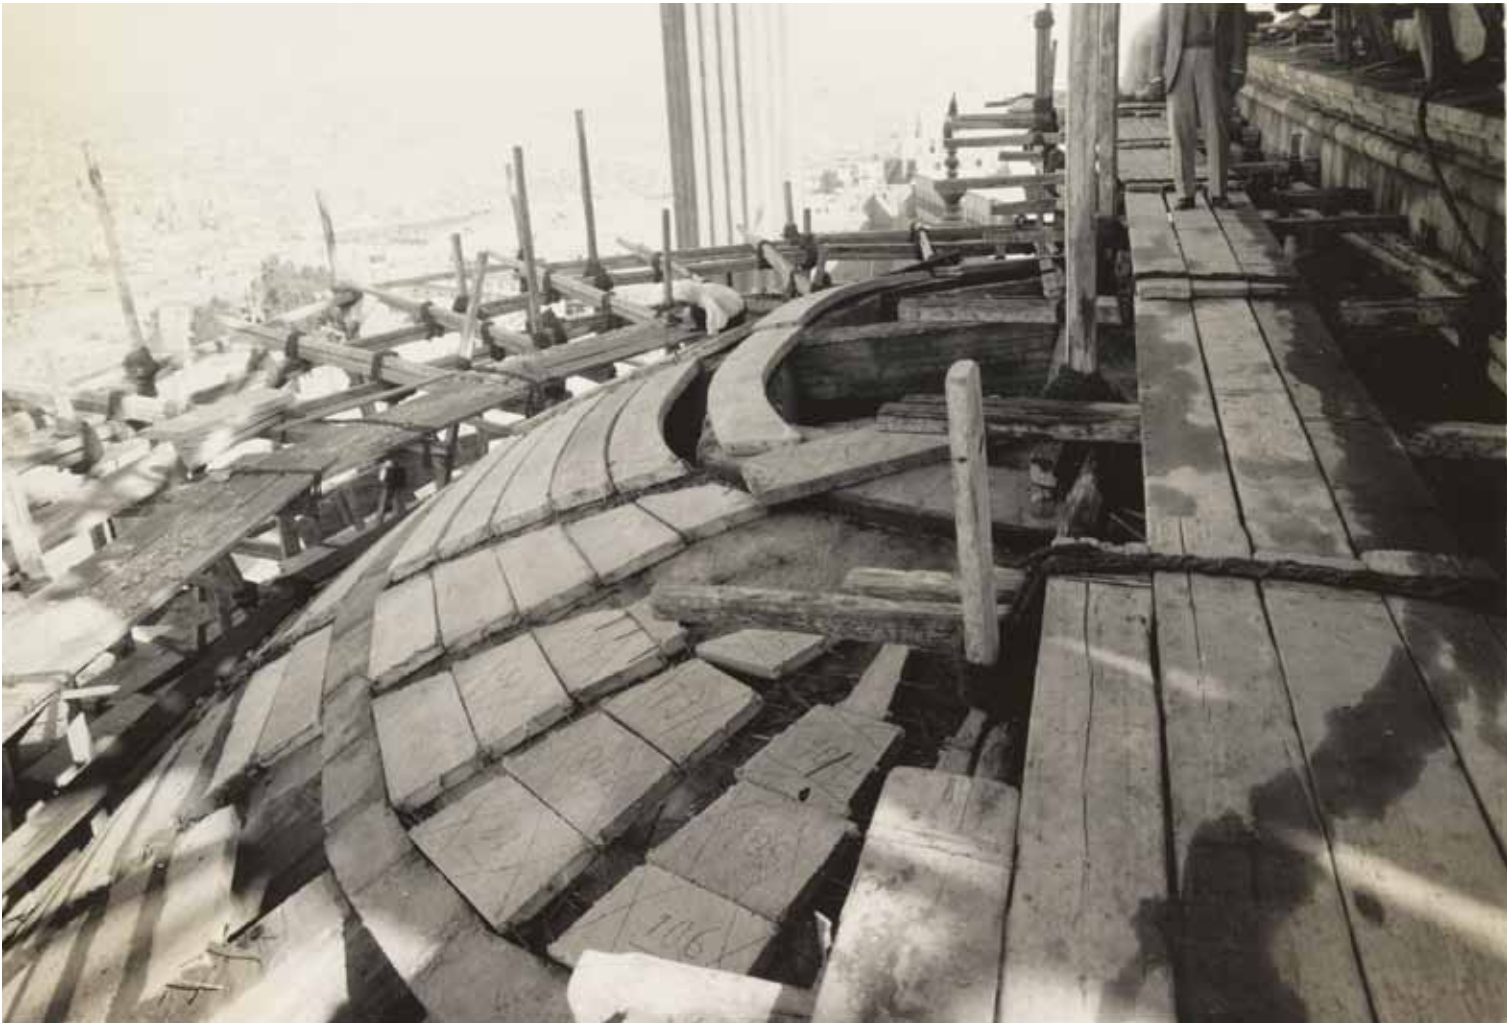
Muhammad Ali Mosque, Cairo:
Reinforcement of the concrete slab at the
base of the northern minaret, August 1934
Plywood forms for a part of the great
dome, September 1934
